HISTORIC PROPERTIES REPORT

ANNISTON ARMY DEPOT
AND
COOSA RIVER STORAGE ANNEX
ALABAMA

FINAL REPORT

JULY 1984

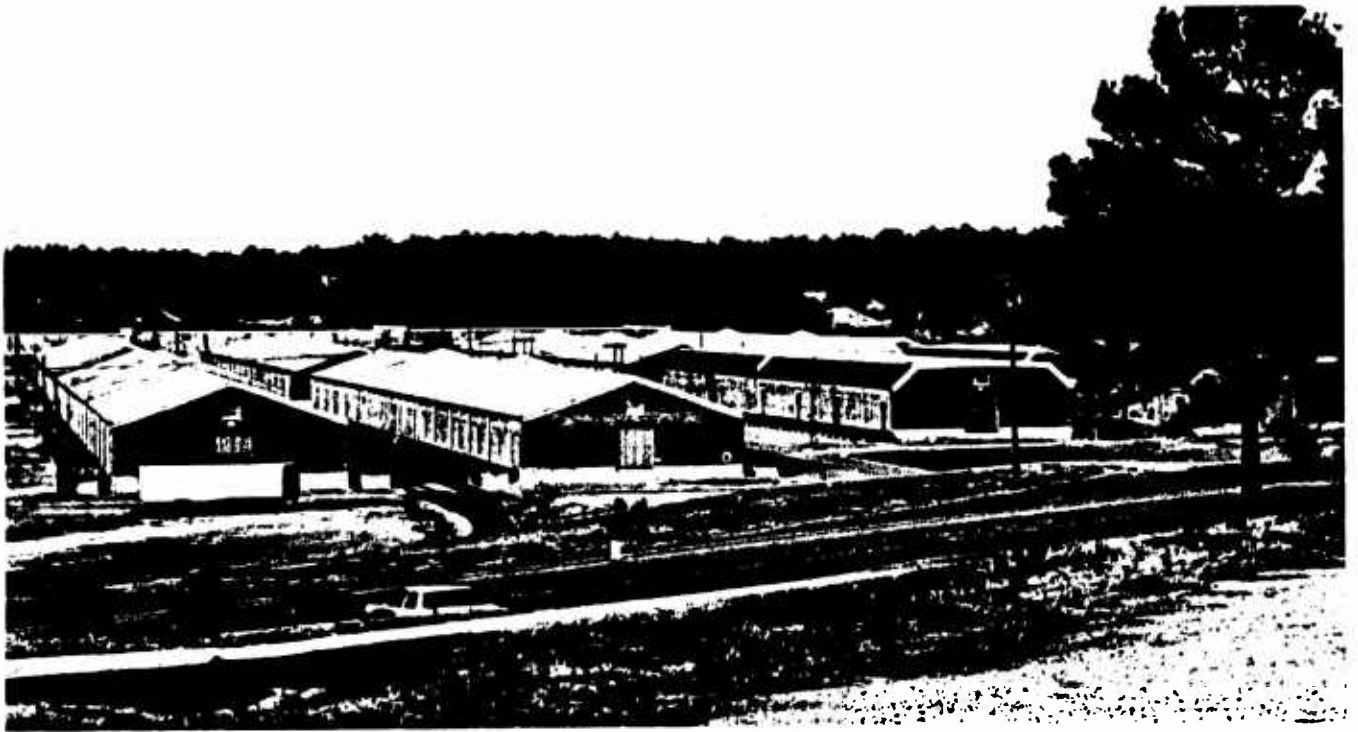
Illustration 4 View of the northeast side of the inert materials storage area. Seventeen brick, gable-roofed warehouses, each divided into three units, and three smaller warehouses were constructed in 1941-1942 for the storage of inert materials. The warehouses are arranged in parallel rows and are located at the south end of the depot. (Source: Field inventory photograph, 1984, Barbara Hightower, Building Technology, Inc.)

During the summer of 1941, construction began on 17 steel framed, brick, gable-roofed warehouses (Buildings 22-38) southwest of the igloo storage area. Each building contains three sections making a total of 51 storage units. Thirty bays with sliding metal doors open onto concrete platforms along two sides of each structure. The rectangular buildings are placed parallel in two rows and are divided on one side by rail lines and on the other by roads. Delays caused by a shortage of construction materials, adverse weather conditions, and labor problems slowed construction progress, and the warehouses were not sufficiently completed for use until February 1942. Three additional brick warehouses (Buildings 39-41) were erected in 1942 in the same area. The three are smaller in size and have combination shed and flat roofs.¹⁰ (Illustration 4)

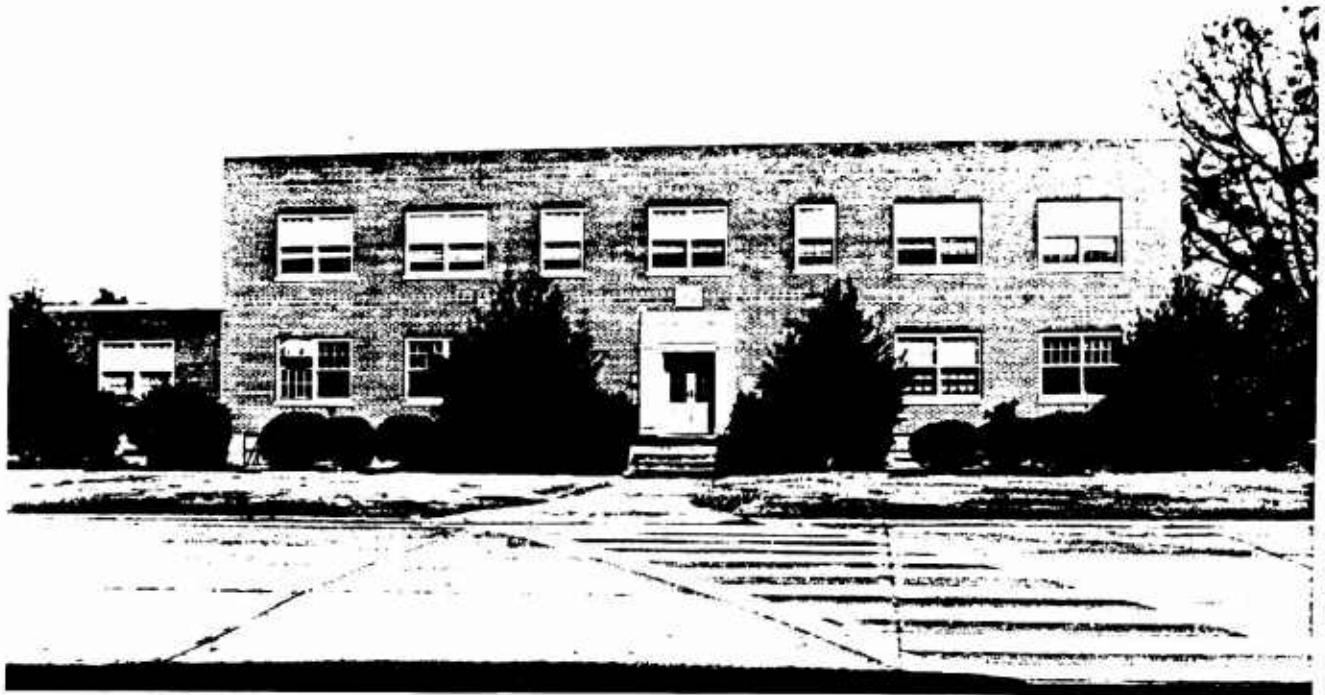
Illustration 6 View of the southwest side of Building 1. This brick structure was originally the headquarters building for the depot. Its major entrance is flanked by fluted stone pilasters and surmounted by a stone entablature with the word ADMINISTRATION carved on it. (Source: Field inventory photograph, 1984, Barbara Hightower, Building Technology, Inc.)

The administration and utility area was constructed west of the inert materials warehouses beginning in 1941. The administration section consists of seven structures. Two are of permanent brick construction and are two stories in height with flat roofs. The major entrances to each are flanked by fluted stone pilasters surmounted by entablatures. The entablature on Building 1 bears the inscription ADMINISTRATION, and the words DISPENSARY and DORMITORY are carved into the entablatures on Building 2. Three wood frame officers' family quarters were erected during 1942 and 1943. Building 48, a one-story, gable-roofed building serves as the commanding officer's residence, and L-shaped two-story structures (Buildings 15 and 16) house two families each. Two additional buildings constructed in 1942 complete the administration section: a two-story, wood frame, gable-roofed structure clad with aluminum siding (Building 47), originally used as the officers' club, and a one-story, clay tile and concrete block building (Building 75) that now serves as the dispensary. (Illustration 6)
